2007 SAMPLE REPORT

Predictive Maintenance Services

Infrared/Thermal Analysis

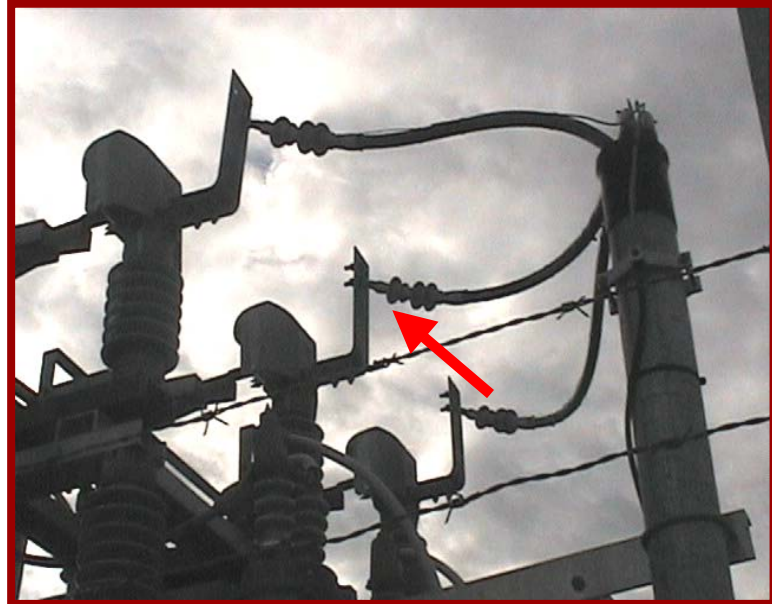
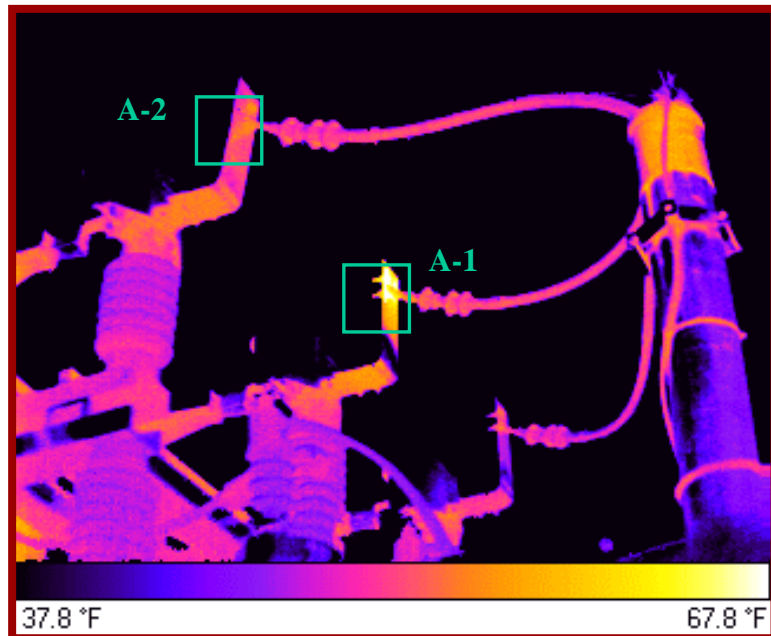
INVENTORY NO. 004

EQUIPMENT: North Cap. Bank Yard Center Phase
Buss-to-Underground Feeder Connection.

FINDINGS: Suspect loose deteriorated Buss-to-Underground Feeder Connection

EXCEPTION TEMP. (Area.1): 71F

REFERENCE TEMP. (Area 2): 50F

DELTA-T: 21F

PRIORITY 2

RECOMMENDATIONS: Inspect, clean, and tighten center phase buss connector and all related components.

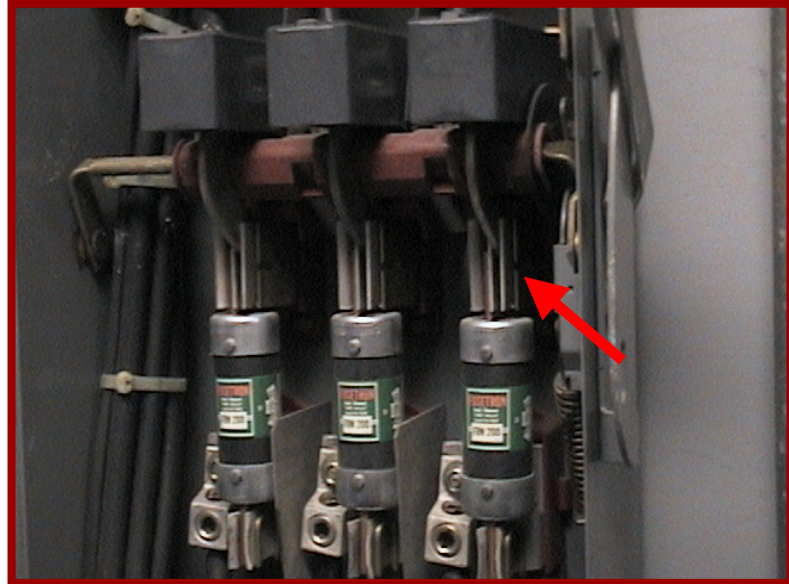
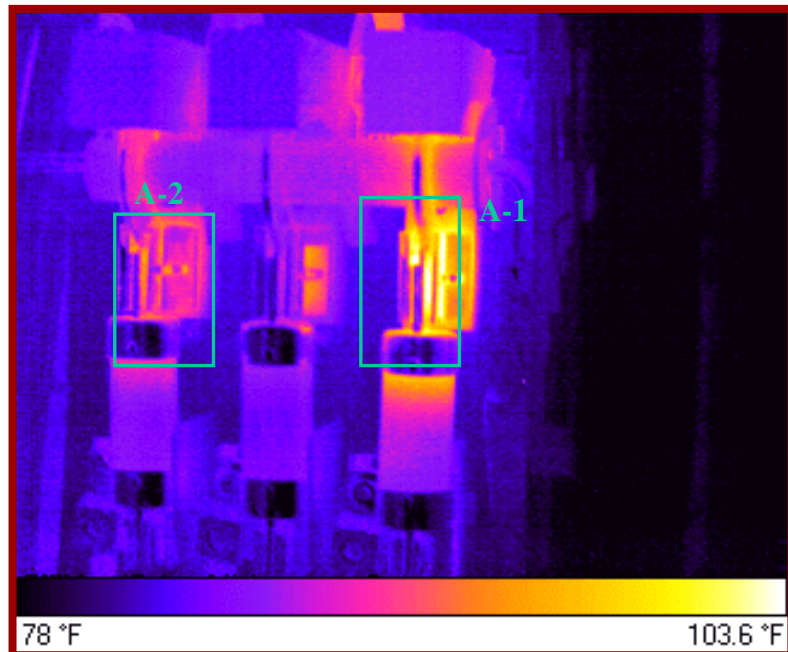
INVENTORY No. 024

EQUIPMENT: Panel LRMA Main Disconnect Right
Phase Top Fuse Holder

FINDINGS: Suspect loose deteriorated fuse holder
components and contacts.

EXCEPTION TEMP. (Area.1): 107F

REFERENCE TEMP. (Area 2): 85F

DELTA-T: 22F

PRIORITY 2

RECOMMENDATIONS: Inspect, clean, and tighten
fuse assembly and related components. Replace fuse and
components if required.

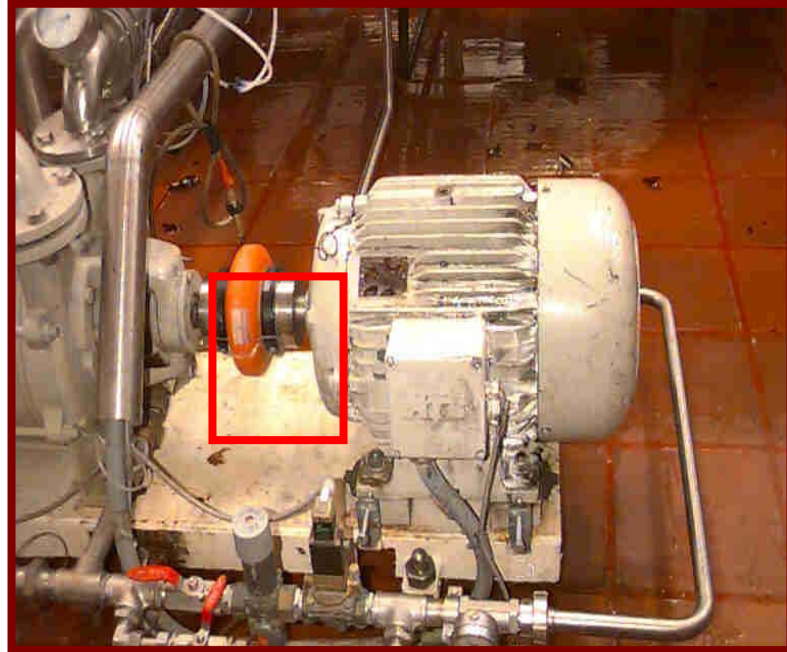
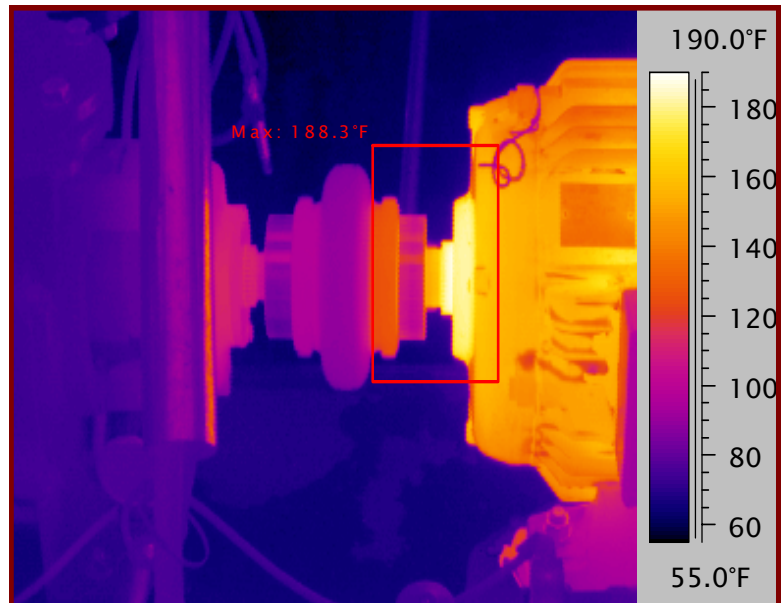
INVENTORY No. 027

EQUIPMENT: Plant No.1 Main Pump
Line No.1

FINDINGS: Uneven thermal pattern on coupling & End-Bell temperatures exceed maximum rise.

EXCEPTION TEMP. (pt.1): 188F

REFERENCE TEMP. (pt.2): 170F

DELTA-T: 18F

PRIORITY 1

RECOMMENDATIONS: Inspect load, shaft alignment and lubrication and comply with manufacturers specification.

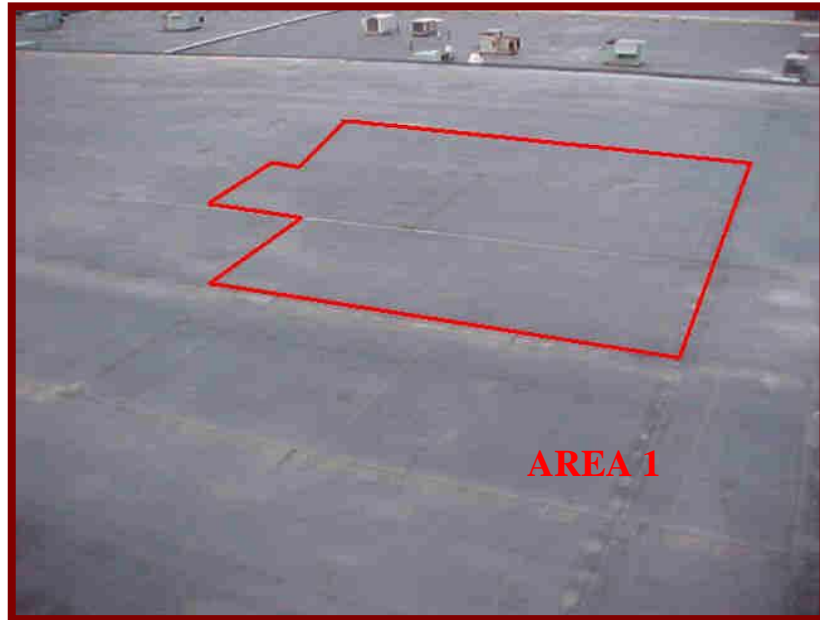
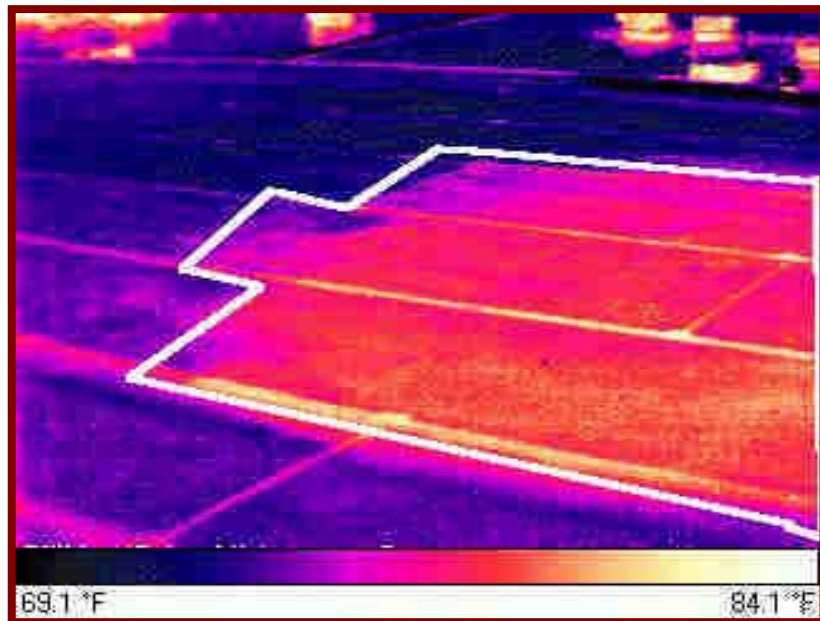
INVENTORY No. 028

EQUIPMENT: Front Office (Area 1)

FINDINGS: Built-Up Construction

A continuous semi-flexible roof coverings of laminates, or piles, of saturated or coated felts alternated with layers of bitumen. Surfaced with asphalted materials.

RECOMMENDATIONS: Consult with an experienced roofing contractor to confirm results. (Core samples are suggested to confirm thermal analysis).

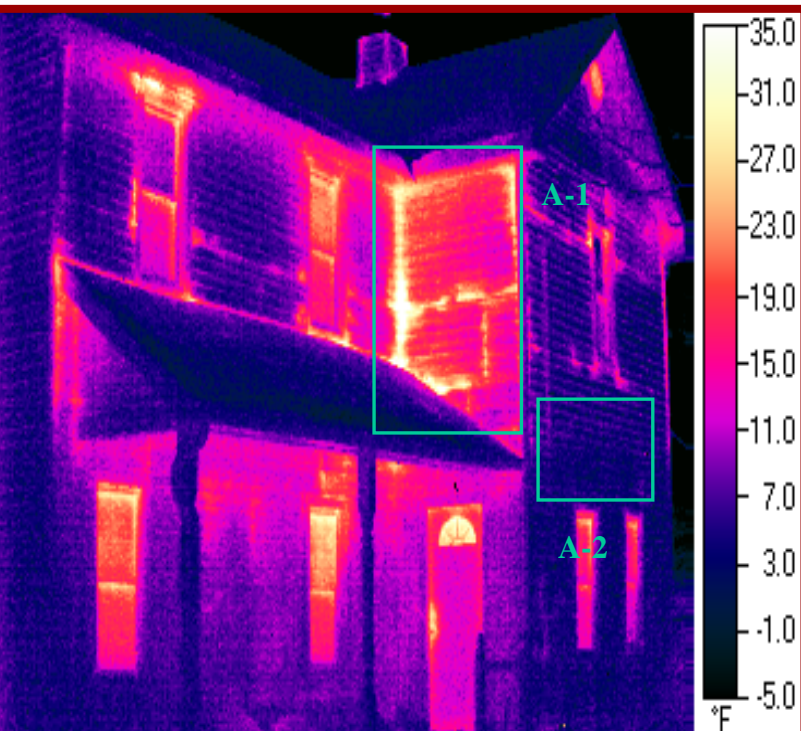
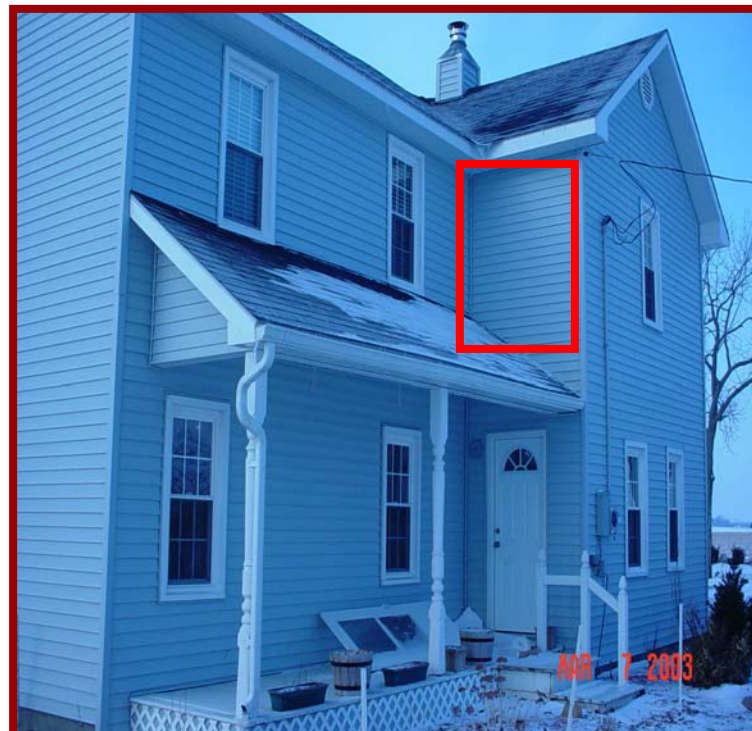
LOCATION: North End East Side (above porch)

EQUIPMENT: Vinyl Siding

FINDINGS: Suspect Thermal Loss due to lack of insulation and/or excessive air flow.

EXCEPTION TEMP. (Area.1): 37F

REFERENCE (Normal) (Area 2): 12F

DELTA-T: 25F

Indicates major discrepancy; repair immediately.
PRIORITY 3

RECOMMENDATION: Further inspect the area of loss and repair as required.

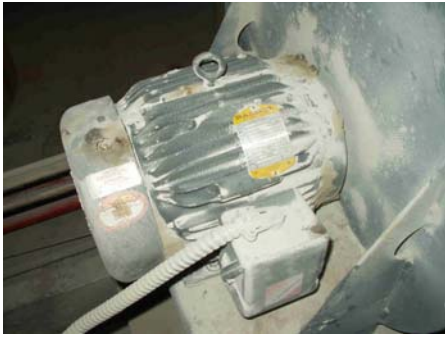
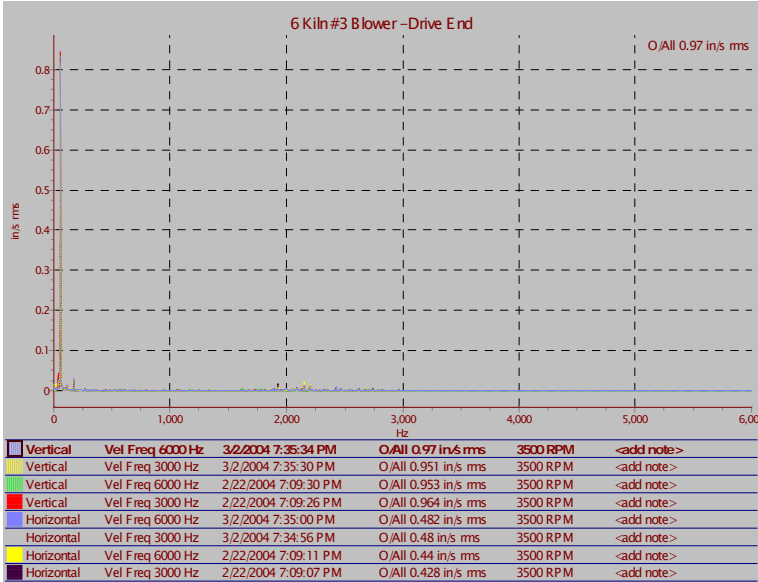
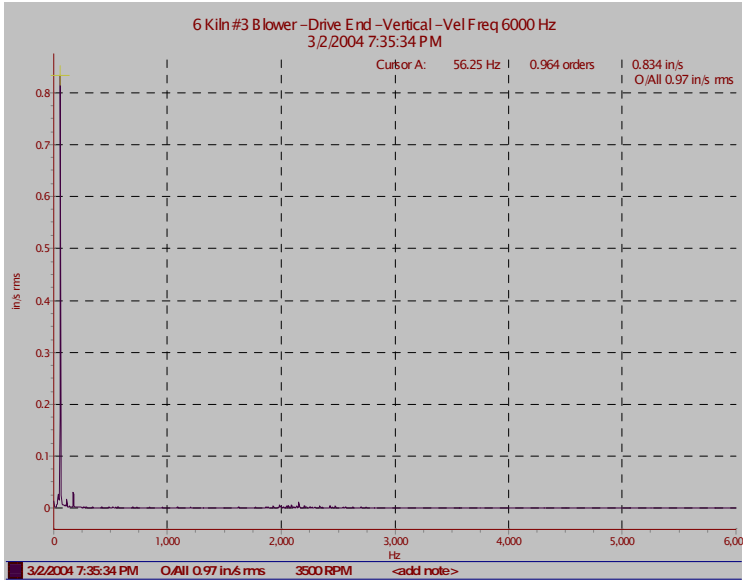
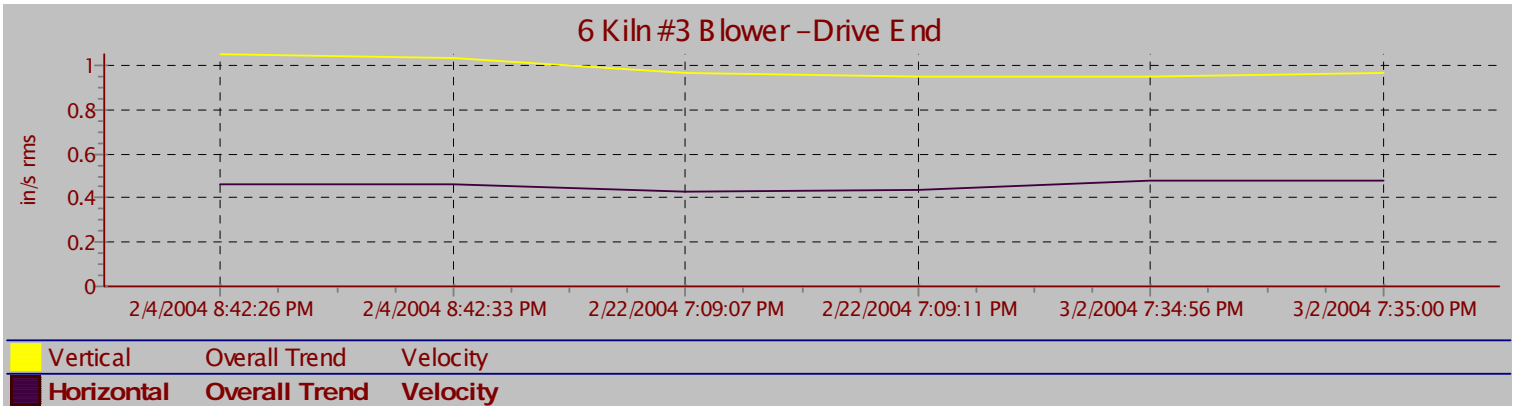
6 Kiln #3 Blower Motor

PRIORITY 2

Findings: Overall amplitudes are high @ 0.97 in/sec. rms.. Condition indicates mass unbalance and/or misalignment.

Recommendations: Have motor PM'd and balanced during next 30 days.

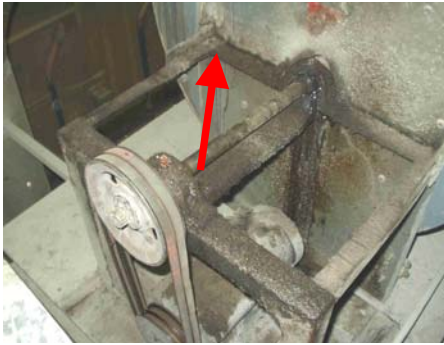
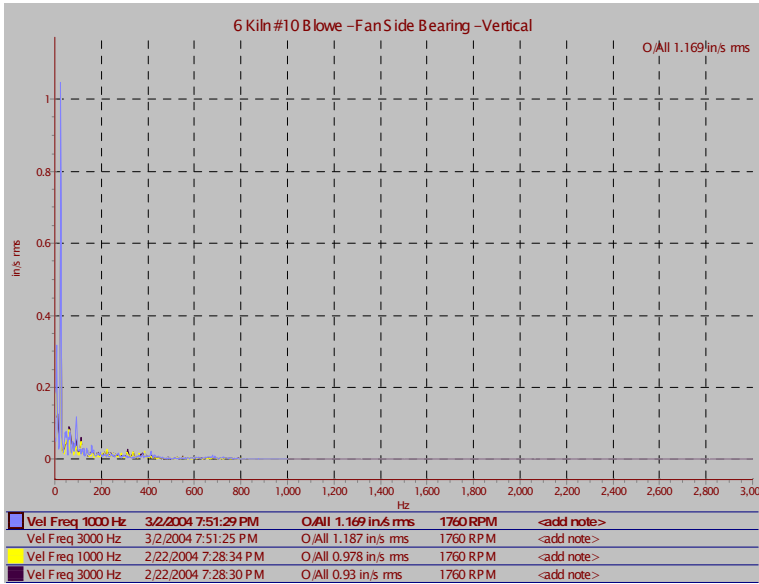
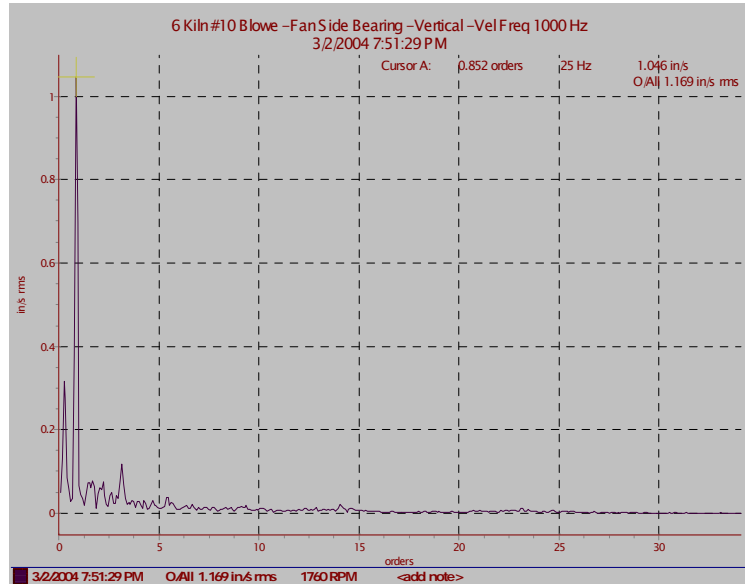
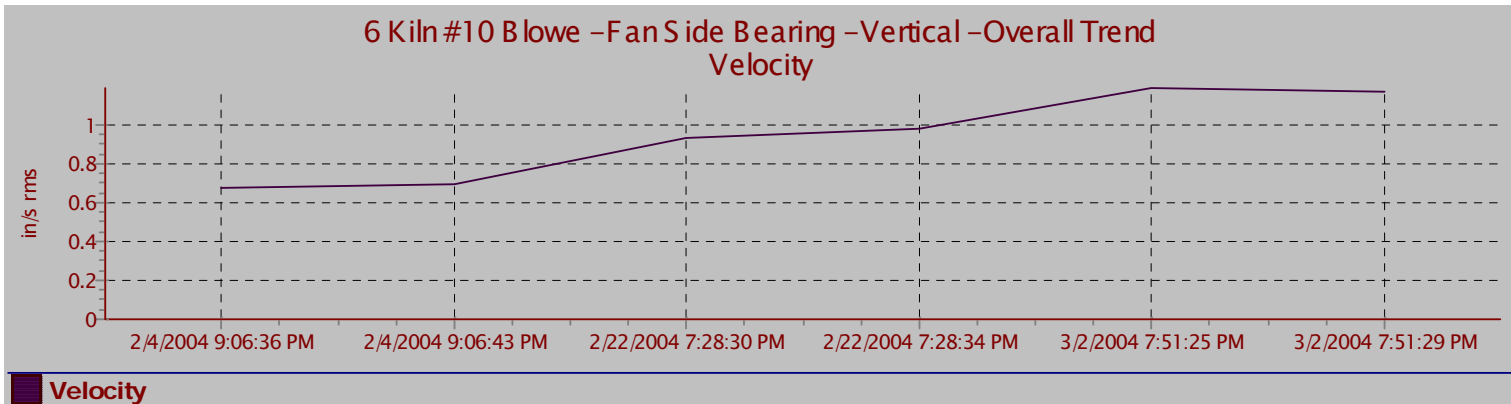
6 Kiln #10 Blower Motor & Bearings

Findings: Overall amplitudes are high @ 1.169 in/sec. rms.. Structure is visibly damaged and causing shaft & fan blades to make contact with hood.

Recommendations: Have structure repaired immediately.

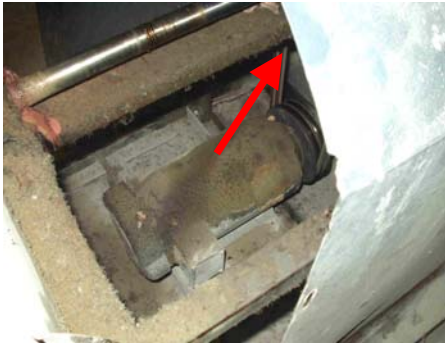
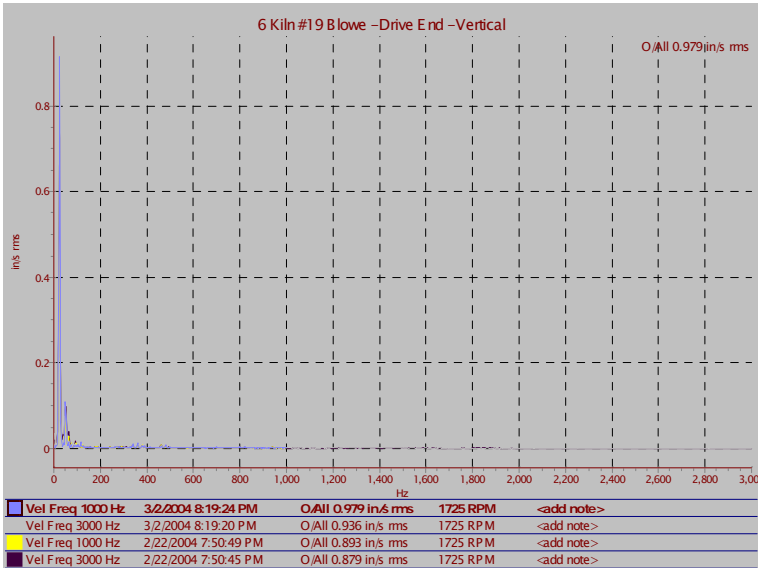
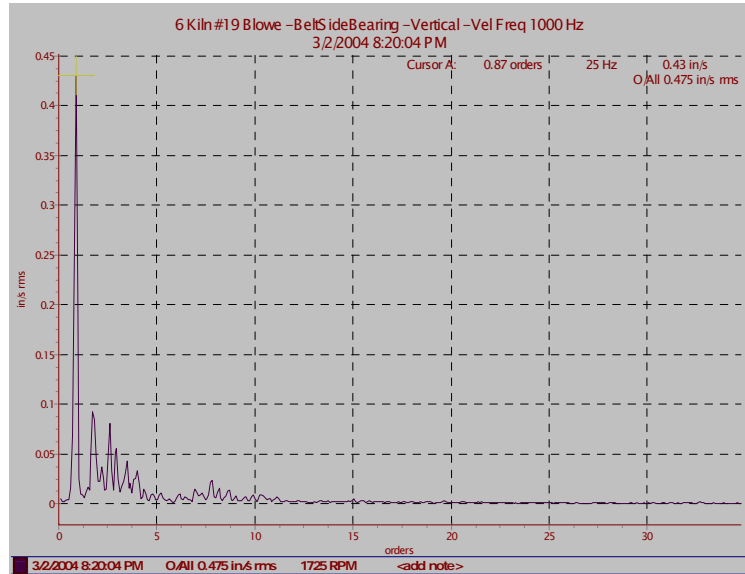
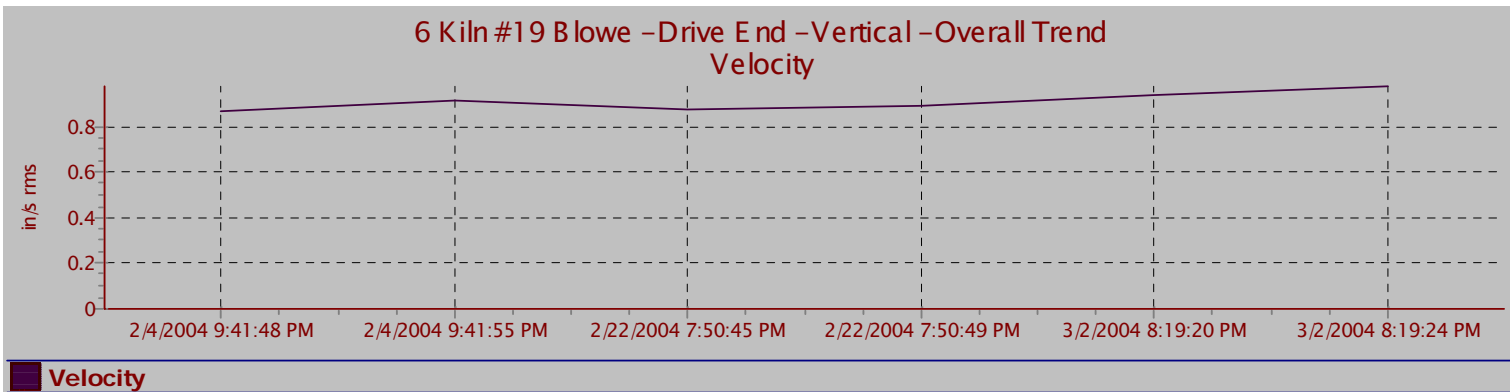
6 Kiln #19 Blower Motor & Bearings

Findings: Overall amplitudes are high in (0.979 in/sec. rms.). Probable unbalance on motor and/or improper belt tension and/or eccentric pulley.

Recommendations: Have motor PM'd and balanced. Check belt tension and inspect pulley during next 30 days.

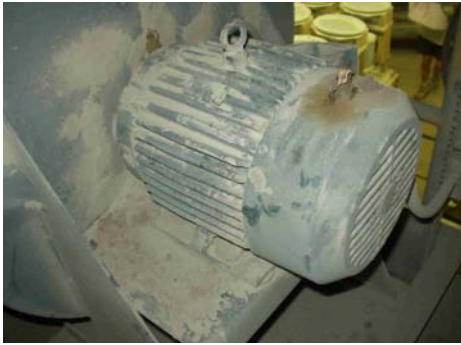
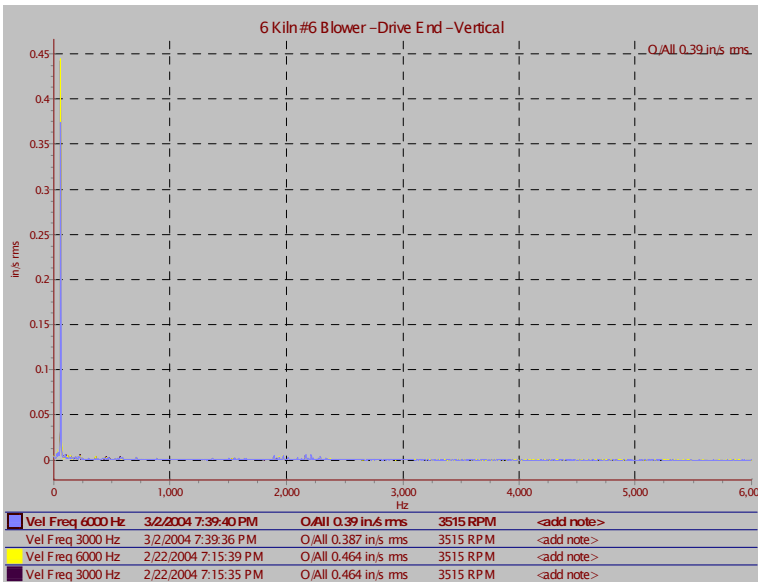
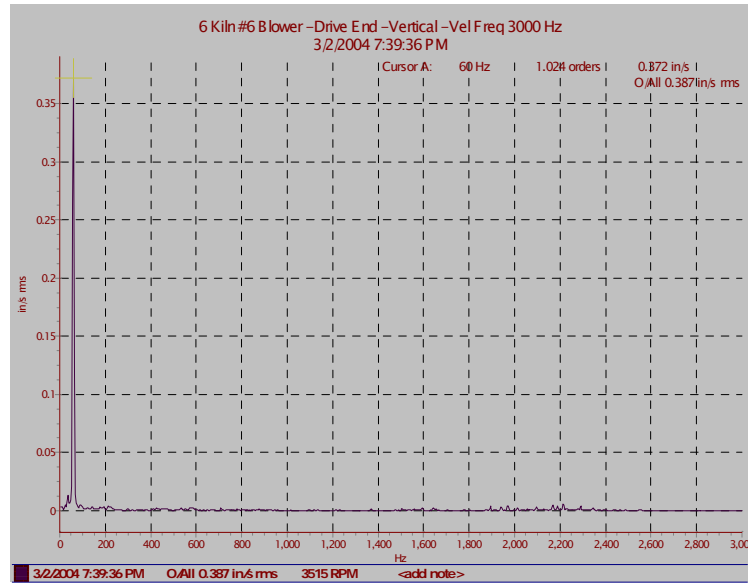
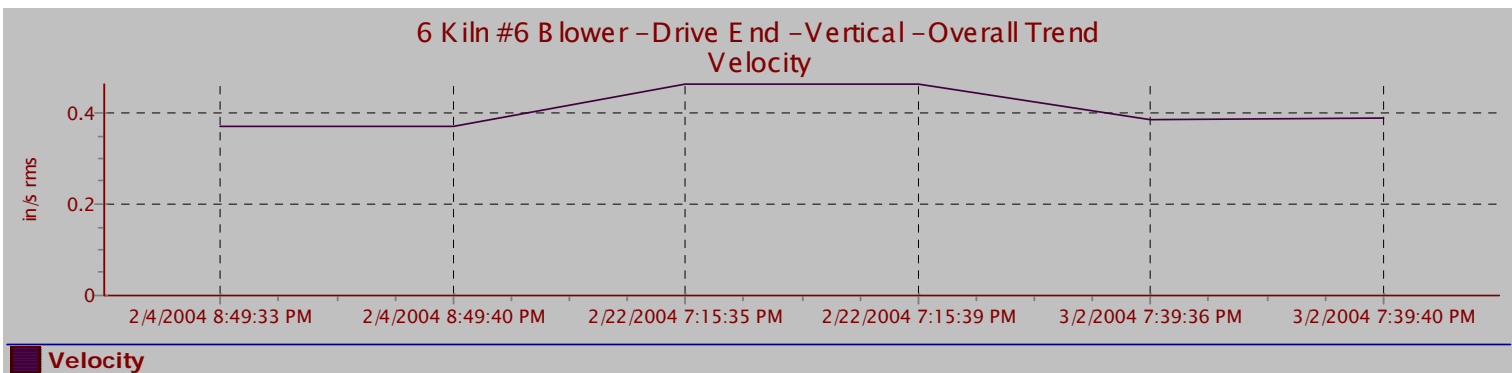
6 Kiln #6 Blower Motor

Findings: Overall amplitudes are @ 0.372 in/sec. rms.. Indicates mass unbalance and/or misalignment. Condition not considered serious @ this time. Continue to monitor.

Recommendations: Schedule equipment for proactive repair. Begin to monitor for any changes in noise or heat.

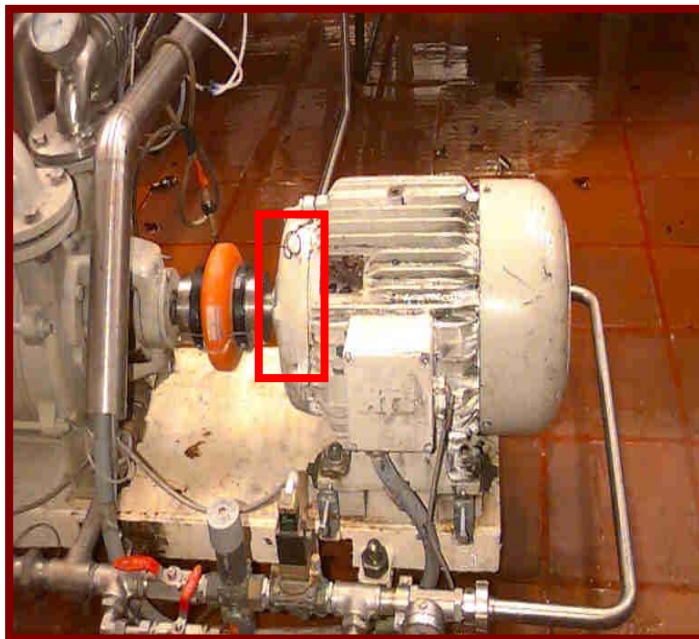
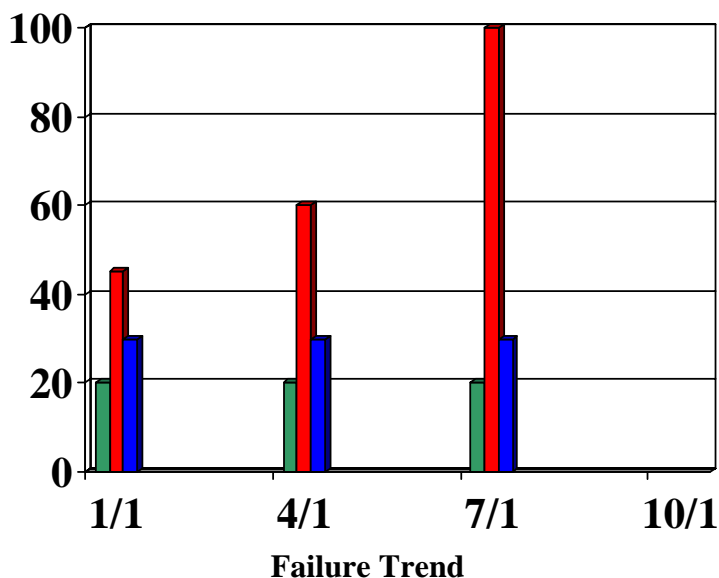
EQUIPMENT: Plant No.1 Main Pump
Line No.1 End Bell Bearing

FINDINGS: Suspect lack of lubrication.

PRIORITY 2

RECOMMENDATIONS: Lubricate bearing to proper specifications and inspect using non-destructive testing. If problem persist replace bearing.

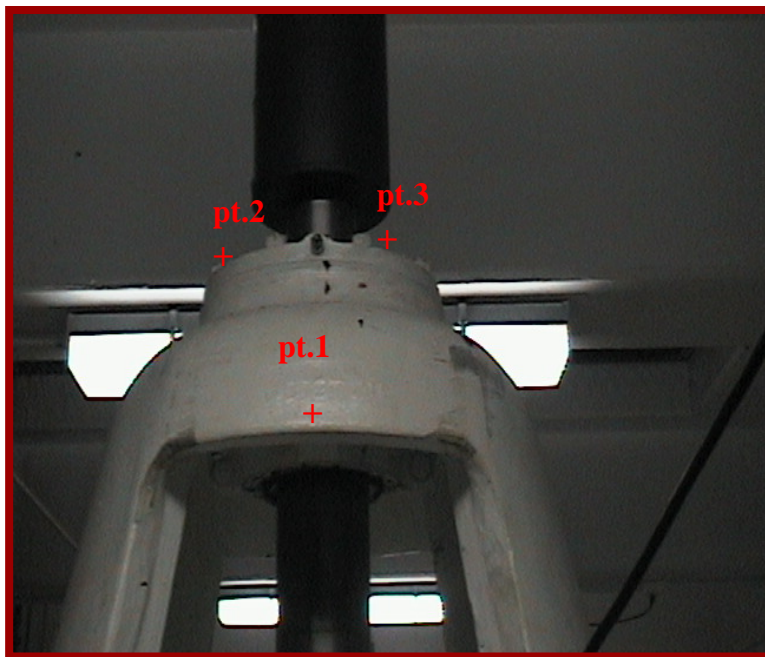
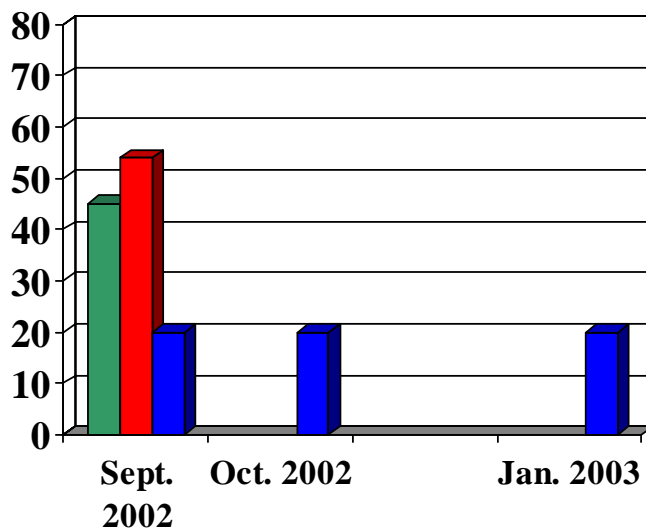
EQUIPMENT: Pump Upper Shaft Bearing

FINDINGS: Normal Range of operation is 40dB-70dB

Decibel Max 56 dB

Decibel Min 45 dB

(Failure Prediction@ 75dB)
