# Vibration Report Trend Sample

Date Collected:  
January 1, 2011

**No. 9 Evaporator  
Circulation Pump #6**

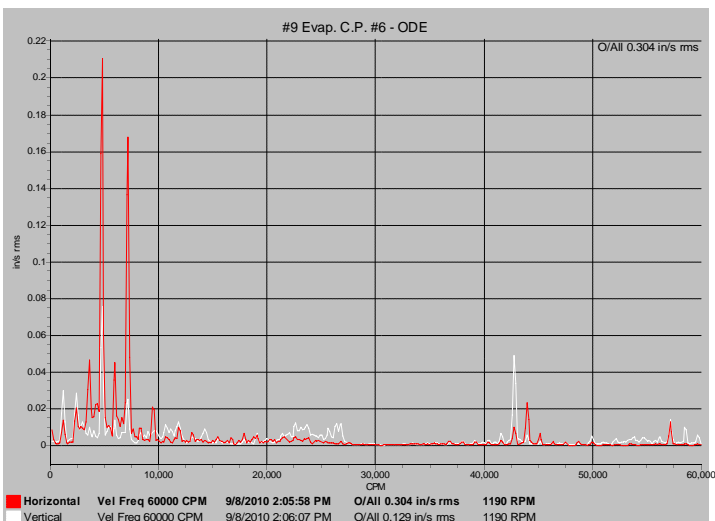
Motor Outboard

**Findings:** Overall amplitudes have increased throughout No. 9 Evaporator Circ. Pump #6 Motor and Pump at the horizontal collection points and data collected at this time indicates presence of potential coupling misalignment and/or possible mass unbalance on motor.

**Recommendations:** Schedule unit to be pm'd, balanced & aligned during next scheduled maintenance down time.
