# Electric Cooperative

**Norwalk, Ohio**

January 25, 2025

# **2025 Thermographic/Infrared Analysis**

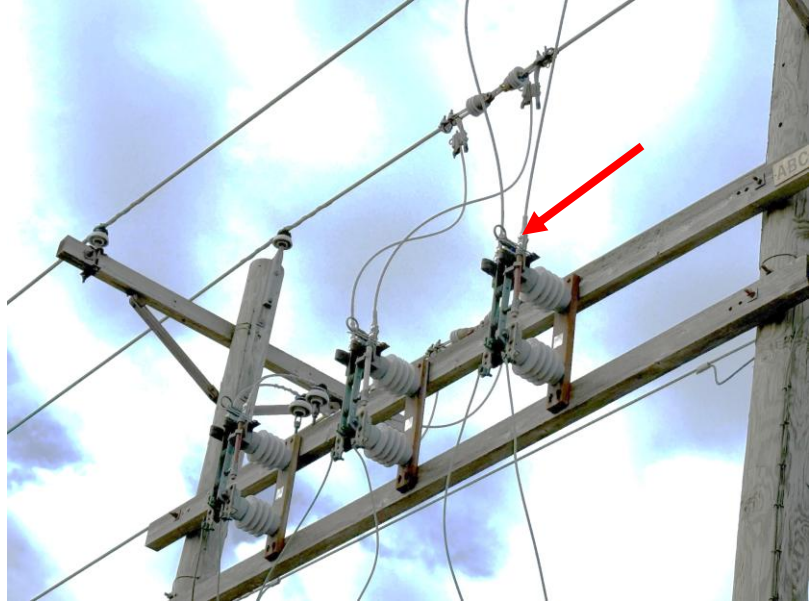
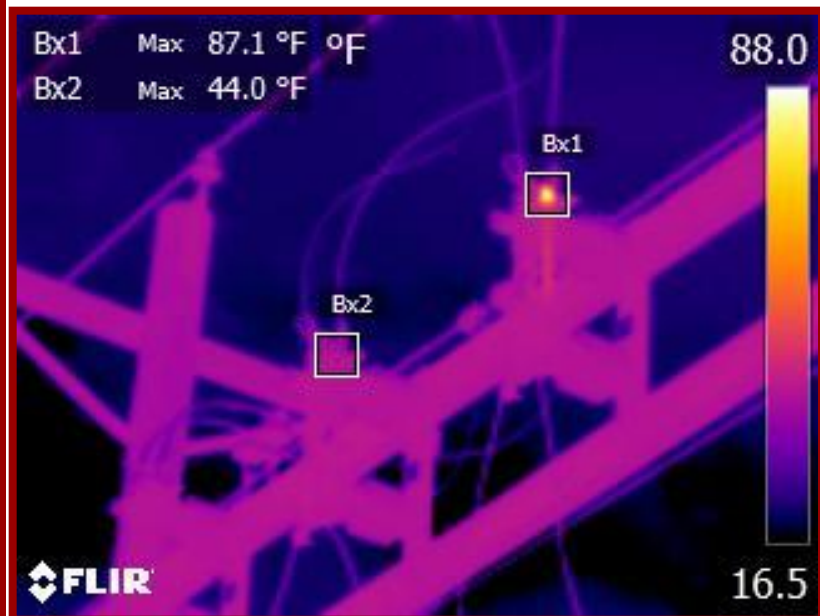
## Exception: #1

**LOCATION:** State Route 589.

**EQUIPMENT:** C-phase bypass switch on device 4515.

**FINDINGS:** Suspect possible poor switch connection.

**EXCEPTION TEMP. (Area 1):** 87F

**REFERENCE TEMP. (Area 2):** 44F

**DELTA-T:** 43F

PRIORITY 3

**RECOMMENDATIONS:** Disassemble, inspect, clean switch connection and check for proper tension .

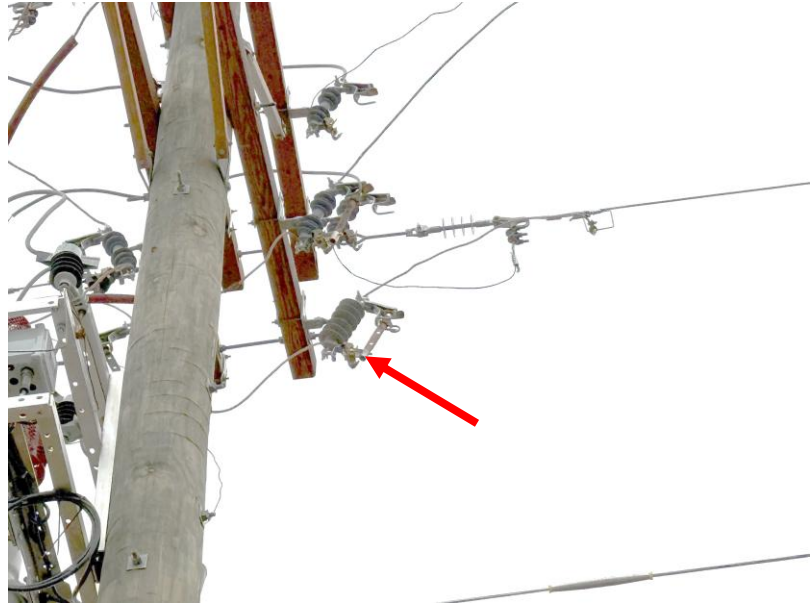
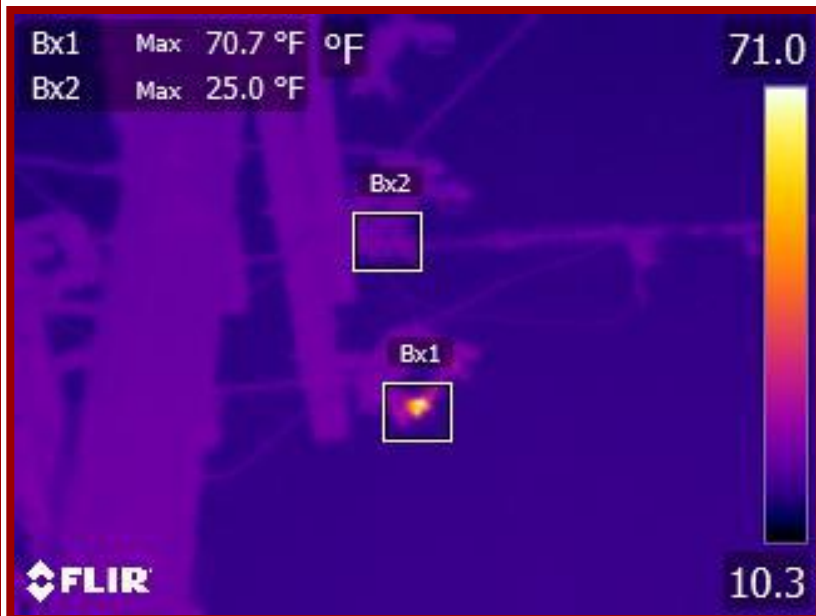
## Exception: #2

**LOCATION:** State Route 55.

**EQUIPMENT:** Bottom switch connection on north phase cut out switch on pole 82947.

**FINDINGS:** Suspect possible poor switch connection.

**EXCEPTION TEMP. (Area 1):** 71F

**REFERENCE TEMP. (Area 2):** 25F

**DELTA-T:** 46F

PRIORITY 3

**RECOMMENDATIONS:** Disassemble, inspect, clean switch connection and check for proper tension .

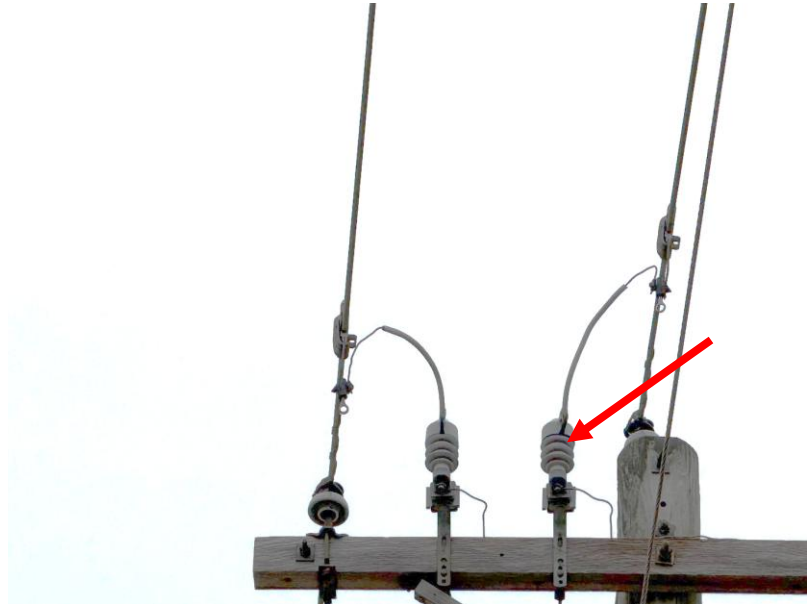
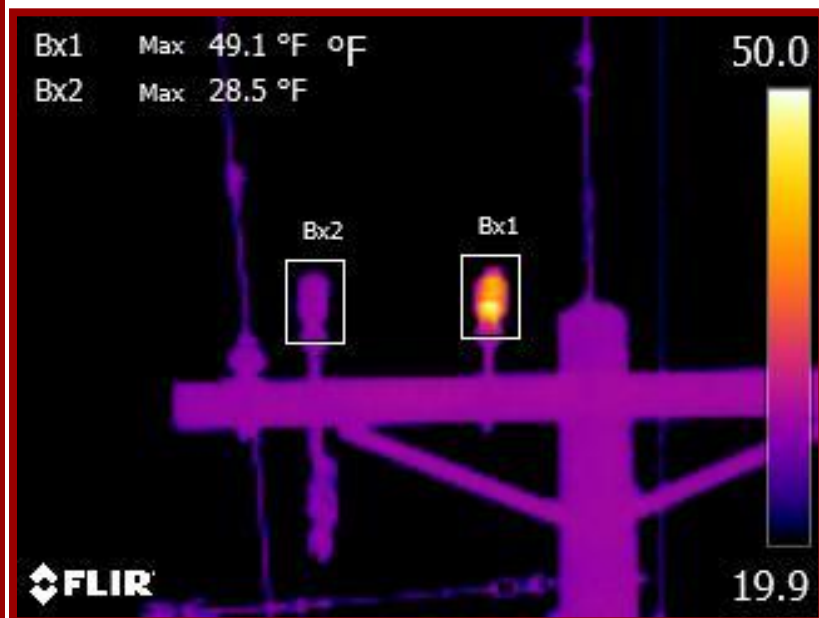
## Exception: #3

**LOCATION:** Pisgah Road.

**EQUIPMENT:** Center phase lightning arrestor on pole 49096.

**FINDINGS:** Suspect possible damaged and/or cracked lightning arrestor.

**EXCEPTION TEMP. (Area 1):** 49F

**REFERENCE TEMP. (Area 2):** 29F

**DELTA-T:** 20F

PRIORITY 2

**RECOMMENDATIONS:** Inspect for cause of heating and correct as required.

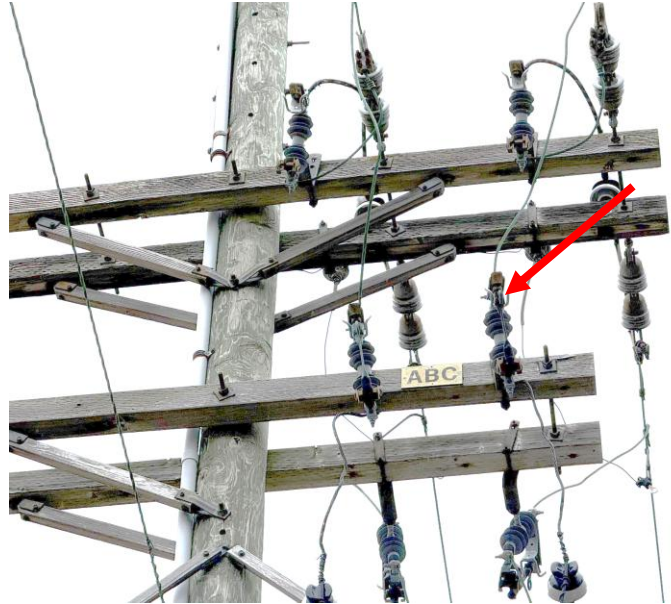
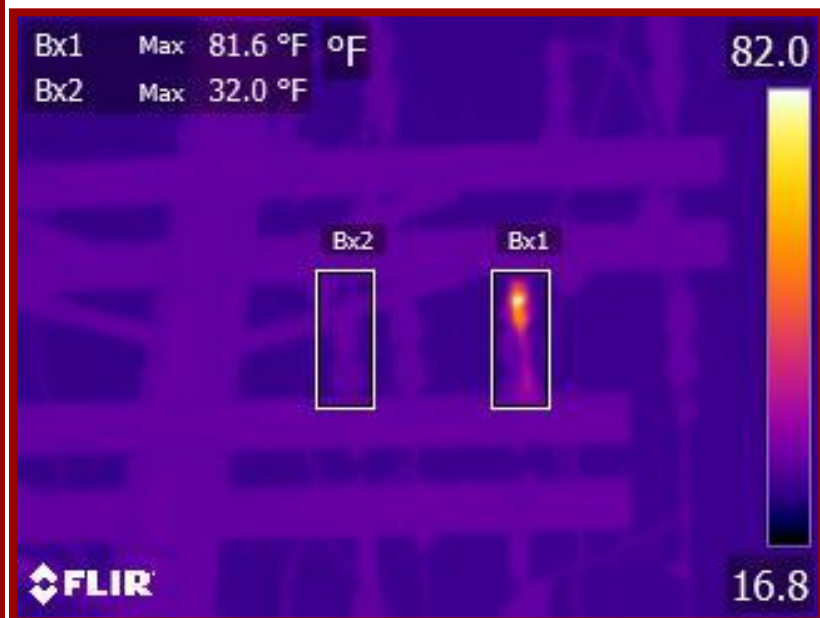
## Exception: #4

**LOCATION:** Neil Pearson Road.

**EQUIPMENT:** Top C-phase cut out switch on middle cross arm on east side of pole 18824.

**FINDINGS:** Suspect possible poor switch connection.

**EXCEPTION TEMP. (Area 1):** 82F

**REFERENCE TEMP. (Area 2):** 32F

**DELTA-T:** 50F

**PRIORITY 3**

**RECOMMENDATIONS:** Disassemble, inspect, clean switch connection and check for proper tension .

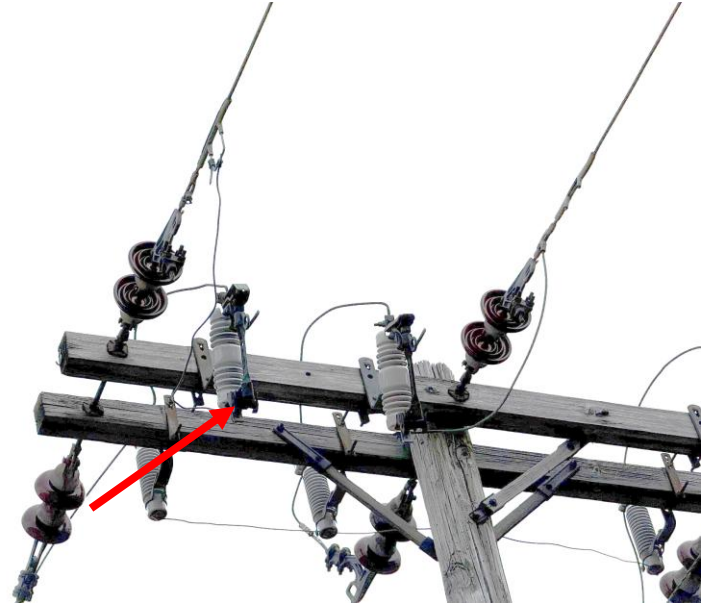
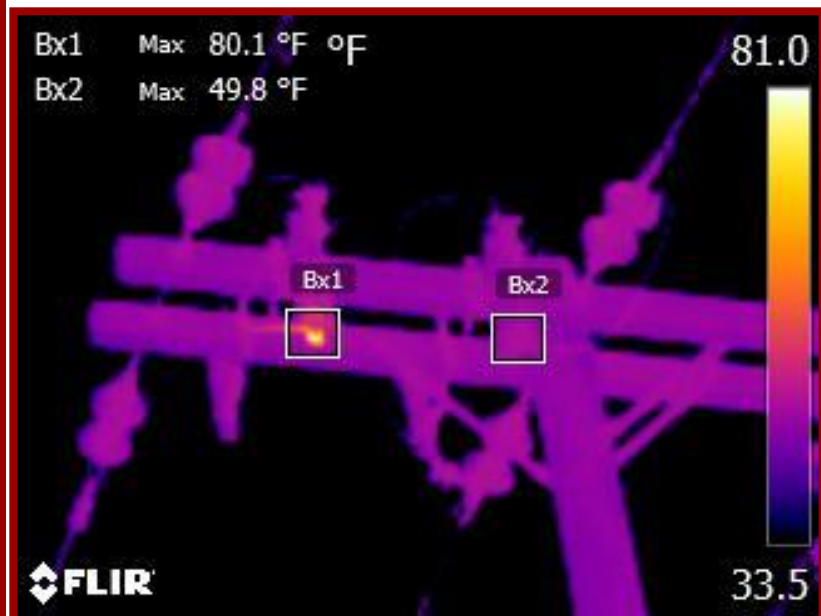
## Exception: #5

**LOCATION:** Johnston Road.

**EQUIPMENT:** Bottom switch connection on north phase cut out switch on pole 36204.

**FINDINGS:** Suspect possible poor switch connection.

**EXCEPTION TEMP. (Area 1):** 80F

**REFERENCE TEMP. (Area 2):** 50F

**DELTA-T:** 30F

PRIORITY 2

**RECOMMENDATIONS:** Disassemble, inspect, clean switch connection and check for proper tension .
