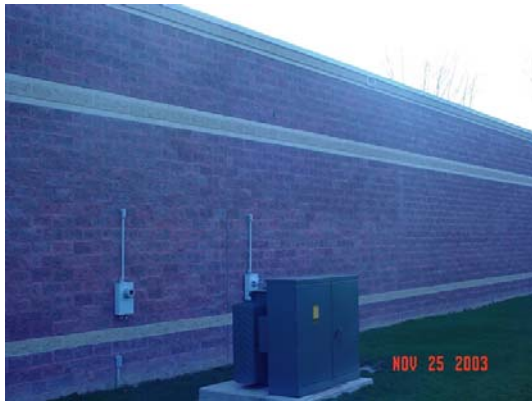
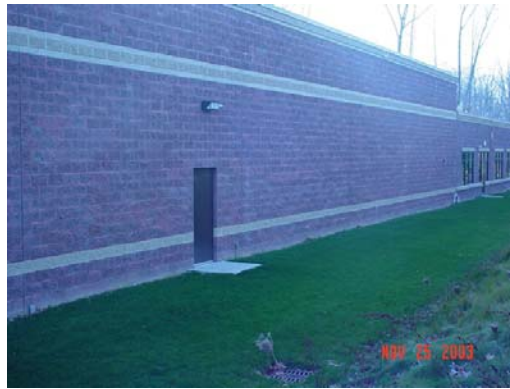
Exterior Type: 12" Split Face Block

Interior Temperature: 65F

Outside Temperature: 24F

Winds: South/West +/- 10mph.

Side: West End

Findings: Normal thermal loss around doors, windows & vents.

Thermal variation shows horizontal reinforcing bond beam.

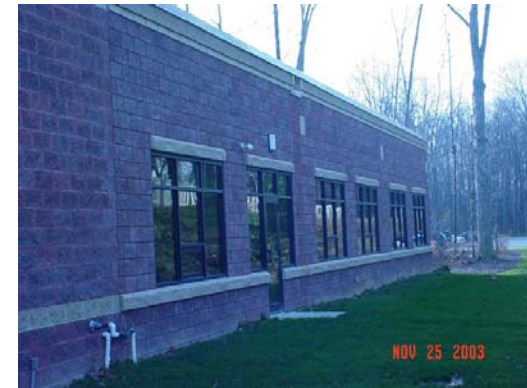
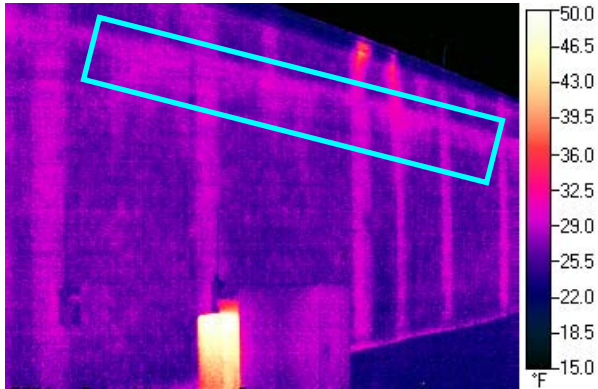
Exterior Type: 12" Split Face Block

Interior Temperature: 65F

Outside Temperature: 24F

Winds: South/West +/- 10mph.

Side: West End

Findings: Normal thermal loss around doors, windows & vents.

Thermal variation shows internal vertical reinforcement.

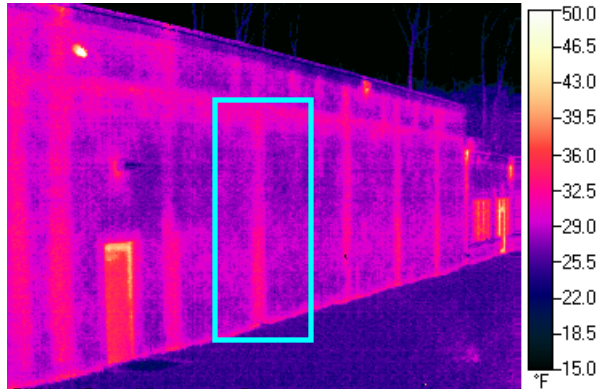
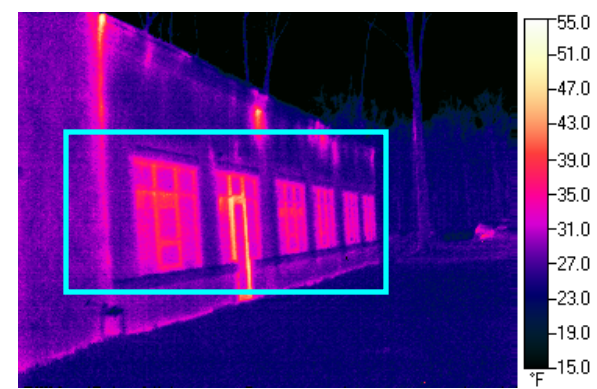
Exterior Type: 8" Split Face Block

Interior Temperature: 65F

Outside Temperature: 24F

Winds: South/West +/- 10mph.

Side: West End

Findings: Normal thermal loss around doors, windows & vents.

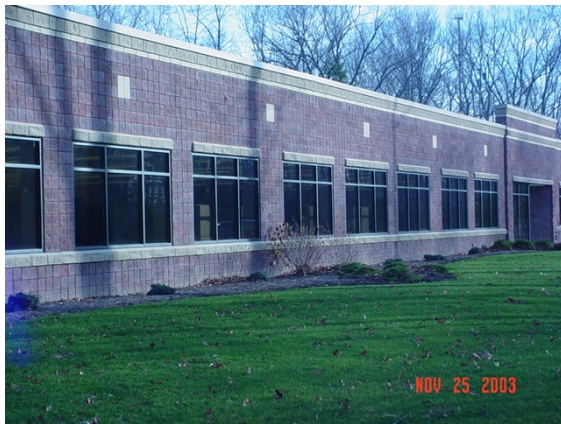
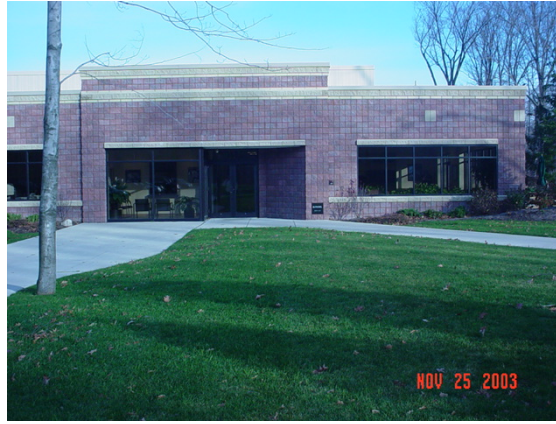
Exterior Type: 8" Split Face Block

Outside Temperature: 24F

Winds: South/West +/- 10mph.

Side: South End

Findings: Normal thermal loss around doors, windows & vents.

Thermal variation shows horizontal reinforcing bond beam.

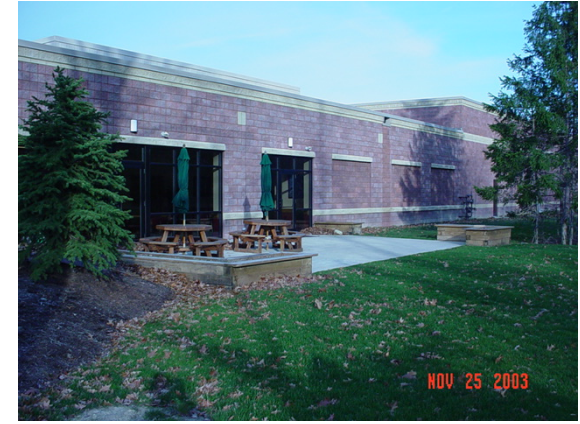
Exterior Type: 8" Split Face Block

Interior Temperature: 65F

Outside Temperature: 24F

Winds: South/West +/- 10mph.

Side: South End

Findings: Normal thermal loss around doors, windows & vents.

Thermal variation shows internal vertical reinforcement.
