# Sample Report

Air Loss Report & Cost-Savings Analysis

4600 Main Street

Inspection Date: July 18, 2026

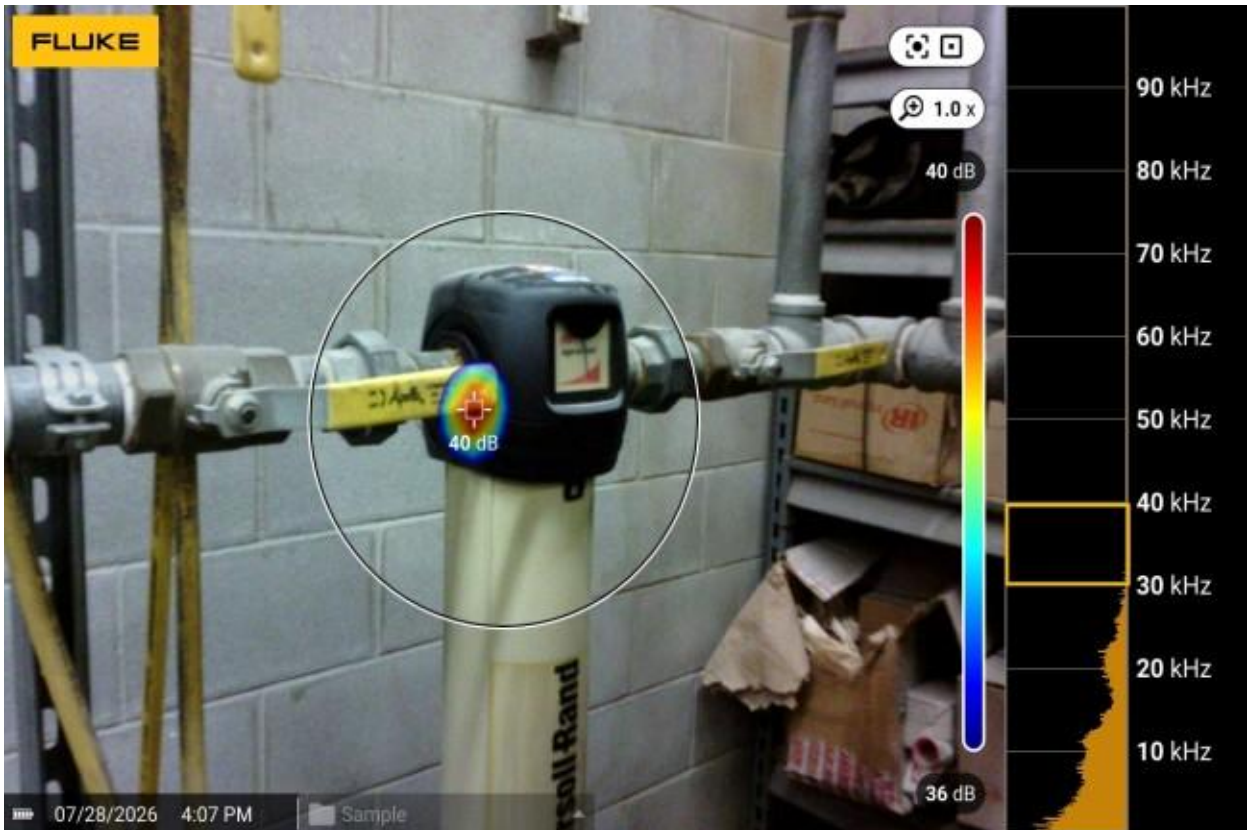
| Name | Sample_260728160653.as2 |

| Sound Pressure Level At Sensor | 39.74 dB |
| Distance To Source | 0.8 Meter |
| Sound Pressure Level At Source | 48.29 dB |
| Asset ID | On regulator |
| Asset Name | Compressor room |

| Estimated Leak Rate | 0.4 CFM |
| Estimated Leak Cost | 140 USD/year |

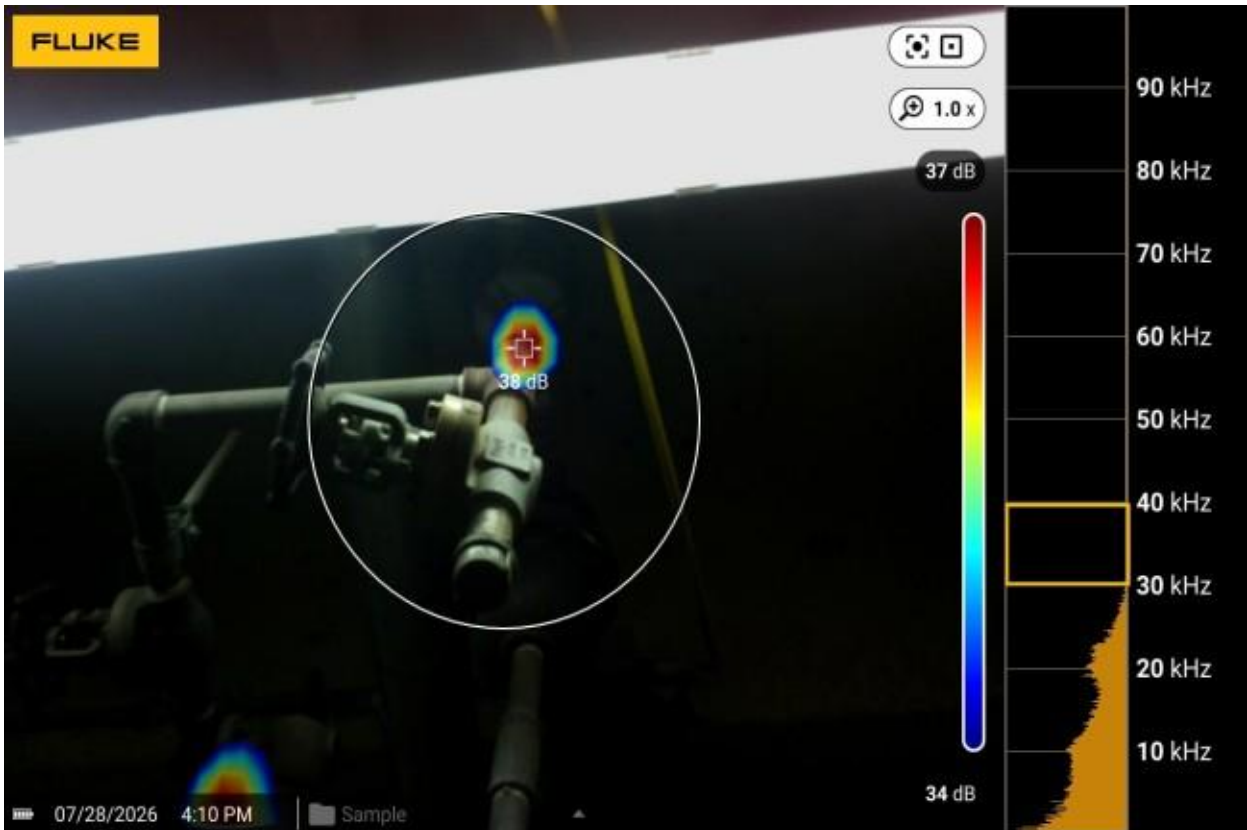
| <b>Name</b> | Sample_260728161002.as2 |

| <b>Sound Pressure Level At Sensor</b> | 37.63 dB |
| <b>Distance To Source</b> | 0.76 Meter |
| <b>Sound Pressure Level At Source</b> | 45.75 dB |
| <b>Asset ID</b> | On valve |
| <b>Asset Name</b> | A room |

| <b>Estimated Leak Rate</b> | 0.3 CFM |
| <b>Estimated Leak Cost</b> | 105 USD/year |

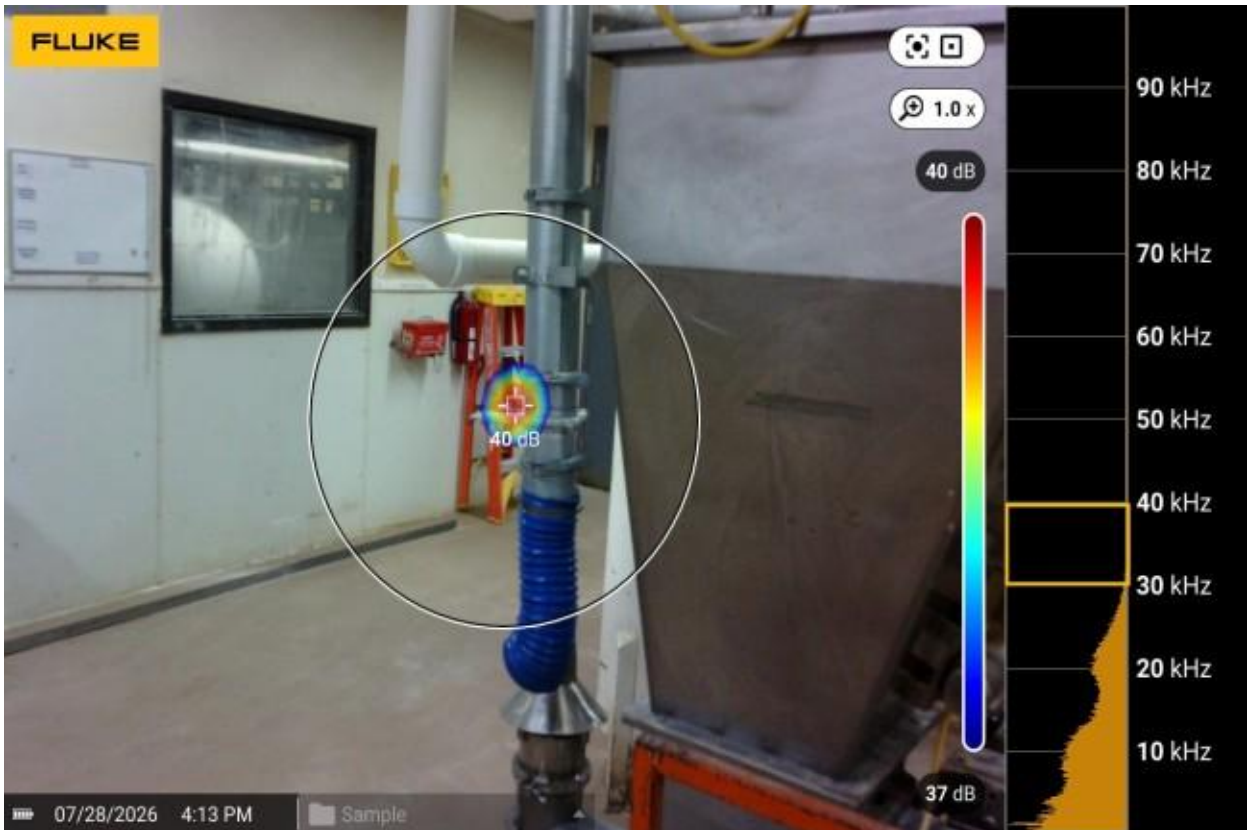
| <b>Name</b> | Sample_260728161330.as2 |

| <b>Sound Pressure Level At Sensor</b> | 39.99 dB |
| <b>Distance To Source</b> | 1.69 Meter |
| <b>Sound Pressure Level At Source</b> | 54.99 dB |
| <b>Asset ID</b> | On blender |
| <b>Asset Name</b> | B room |

| <b>Estimated Leak Rate</b> | 0.4 CFM |
| <b>Estimated Leak Cost</b> | 153 USD/year |

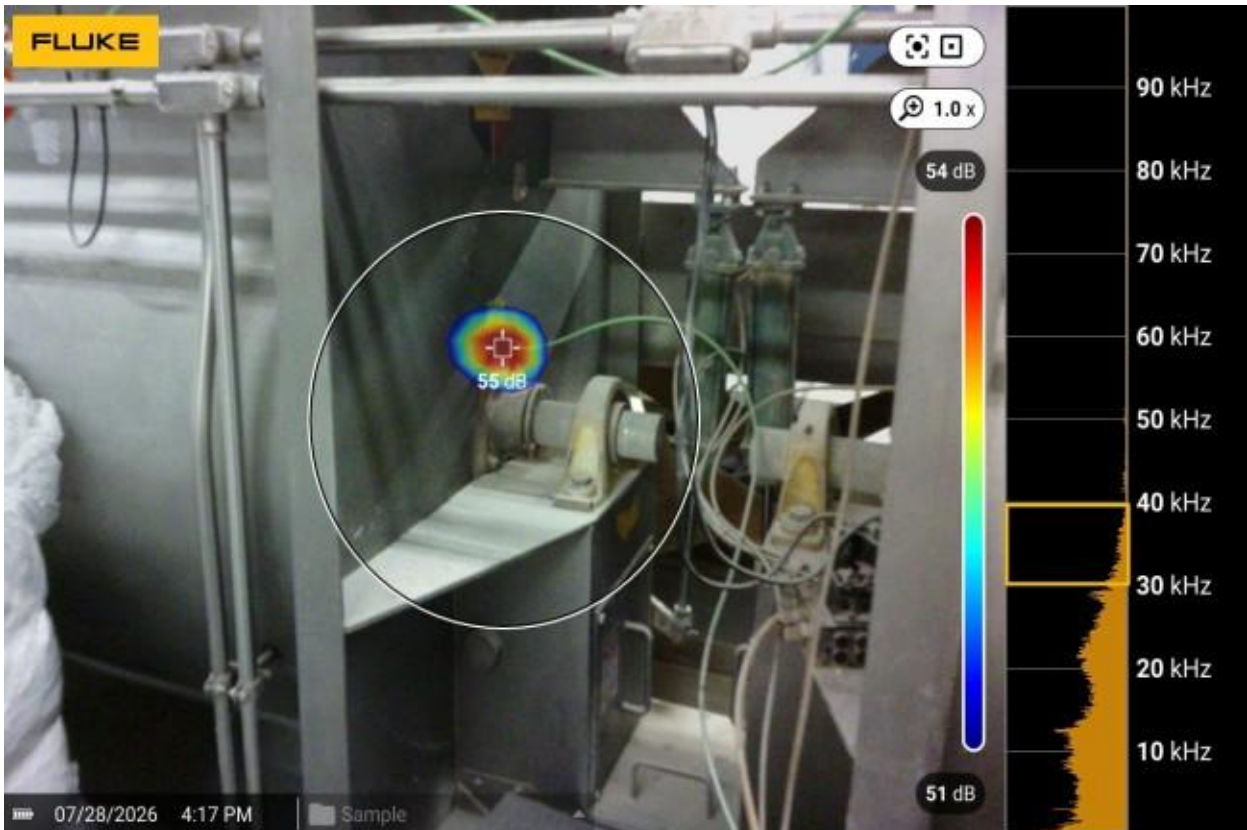
| Name | Sample_260728161648.as2 |

| Sound Pressure Level At Sensor | 54.61 dB |
| Distance To Source | 1.91 Meter |
| Sound Pressure Level At Source | 70.68 dB |
| Asset ID | Slip fitting |
| Asset Name | E room |

| Estimated Leak Rate | 0.3 CFM |
| Estimated Leak Cost | 120 USD/year |

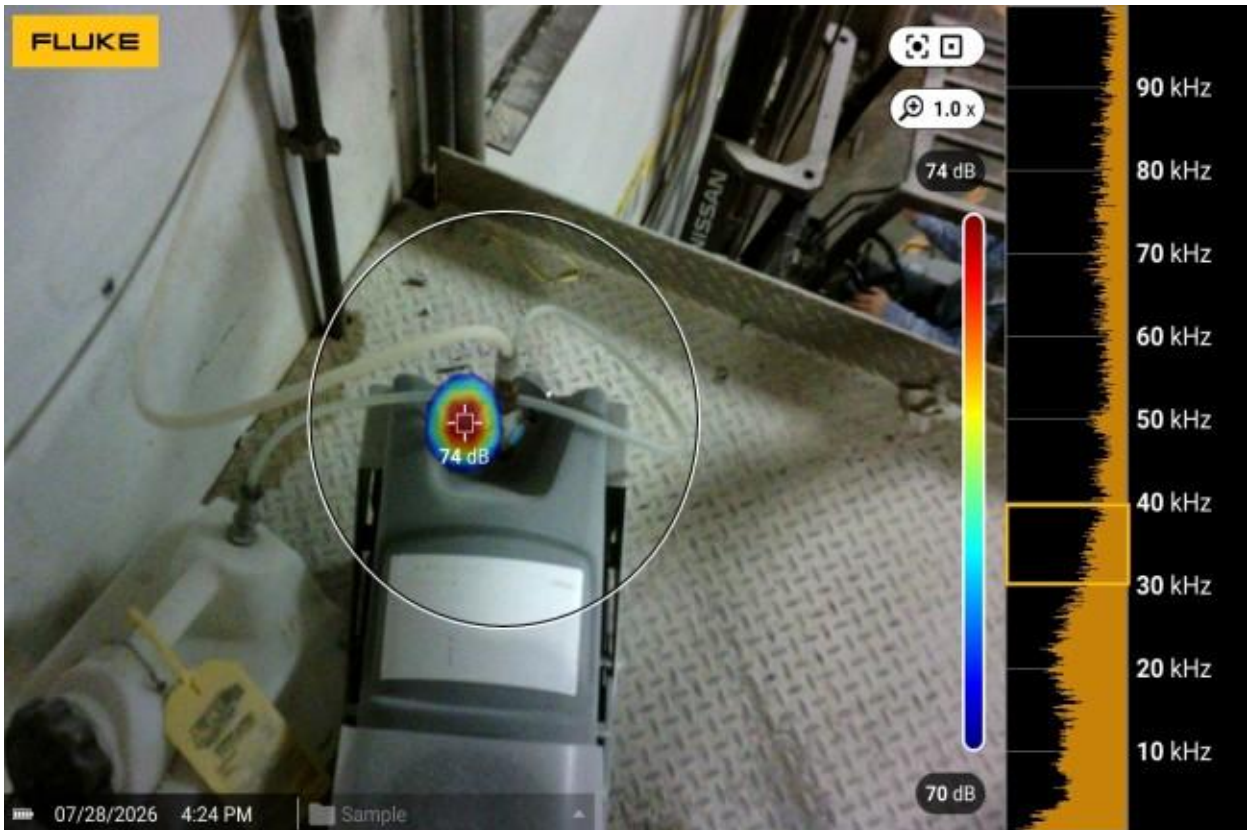
| Name | Sample_260728162415.as2 |

| Sound Pressure Level At Sensor | 74.36 dB |
| Distance To Source | 1.09 Meter |
| Sound Pressure Level At Source | 85.58 dB |
| Asset ID | Boot sprayer |
| Asset Name | Outside office |

| Estimated Leak Rate | 0.8 CFM |
| Estimated Leak Cost | 329 USD/year |

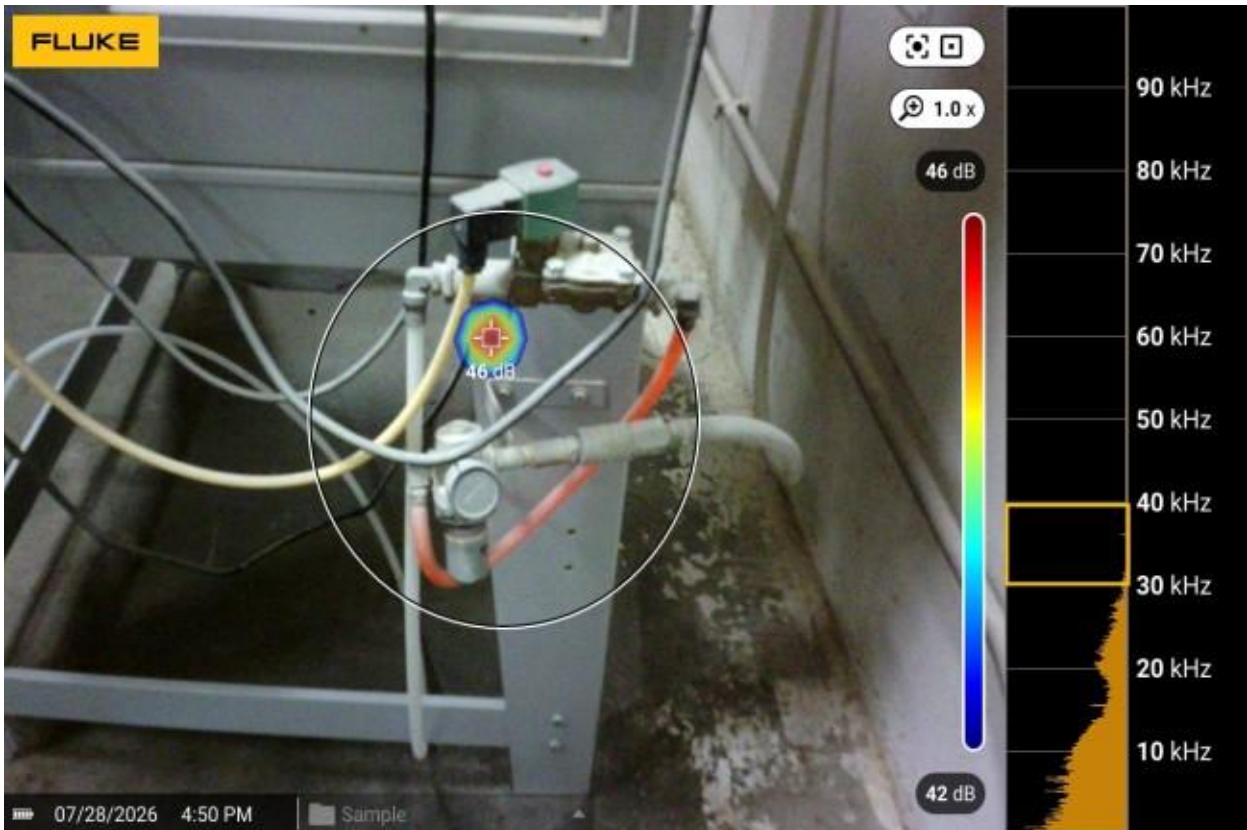
| Name | Sample_260728165037.as2 |

| Sound Pressure Level At Sensor | 46.04 dB |
| Distance To Source | 0.93 Meter |
| Sound Pressure Level At Source | 55.86 dB |
| Asset ID | Regulator |
| Asset Name | Sand blaster |

| Estimated Leak Rate | 0.3 CFM |
| Estimated Leak Cost | 108 USD/year |
